**Meeting of the**  
**ESTATES COMMITTEE**  
**Will be held at the Springfield Centre,**  
**Springfield Boulevard, Springfield**  
**on**  
**Tuesday 11 June 2024 at 6.30pm**

# Annual Inspection Report

**Kernow Crescent Play Area**

<b>Client:</b>	Campbell Park Community Council
<b>Address:</b>	1 Pencarrow Place Fishermead Milton Keynes MK6 2AS
<b>Date:</b>	7th May 2024
<b>Inspector:</b>	Peter Briggs

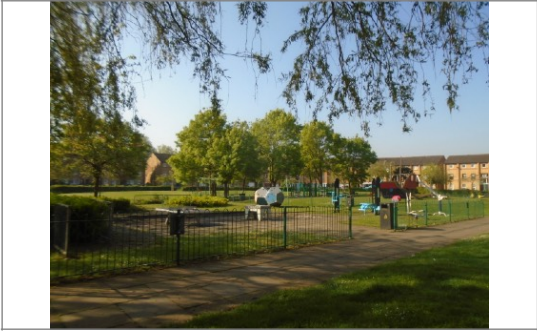
Uneven pathway in places. Possible trip hazard. <b>Recommendation:</b> Repair as required.	8

As above finding. <b>Recommendation:</b> As above comment.	8

Distorted fence rail(s). <b>Recommendation:</b> Repair as required.	4

Damaged bow top fencing. <b>Recommendation:</b> Monitor this condition.	5

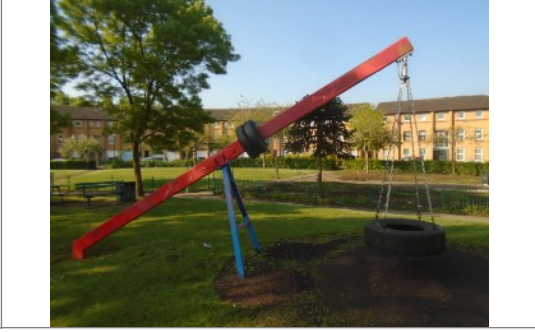
<b>Item</b>	Pendulum Swing				
<b>Supplier</b>	Nijha Lochem				
<b>Surface</b>	Rubber Bonded Fibre				
<b>Risk Rating Overall</b>	Very Low	Low	Medium	High	Unacceptable
				13

Possible wear to universal joint and chains/bearings. <b>Recommendation:</b> Investigate this area following recommended inspection/ maintenance scheduling from the manufacturer.	12

Worn bearings/"D" shackles. <b>Recommendation:</b> Investigate and monitor to replace as required asap.	12

Damaged tyre wall sections. <b>Recommendation:</b> Replace tyre asap.	12

Rubber Bonded Fibre breaking up. <b>Recommendation:</b> Repair/replace as necessary.	7

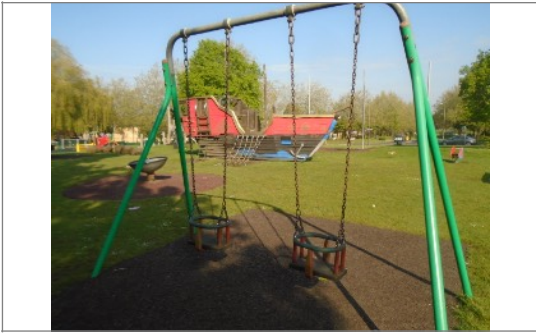
<b>Item</b>	1 Bay 2 Cradle Swing				
<b>Supplier</b>	Sutcliffe				
<b>Surface</b>	Rubber Bonded Fibre				
<b>Risk Rating Overall</b>	Very Low	Low	Medium	High	Unacceptable
			12

Worn chains evident.  
**Recommendation:**  
 Monitor to replace at 40% diameter of wear asap.

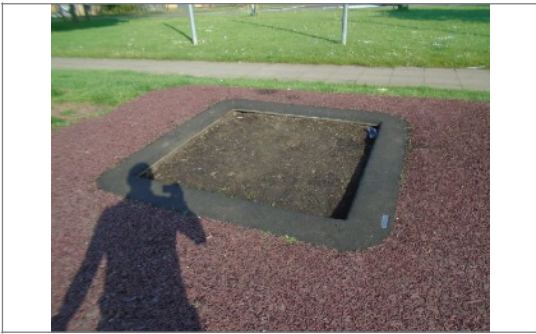
<b>Item</b>	Trampoline				
<b>Supplier</b>	Unknown				
<b>Surface</b>	Rubber Bonded Fibre				
<b>Risk Rating Overall</b>	Very Low	Low	Medium	High	Unacceptable
		7

Possible foot entrapment.  
**Recommendation:**  
 Monitor use.

Missing trampoline pad evident.  
**Recommendation:**  
 Consider removing item, item infilled with soil.

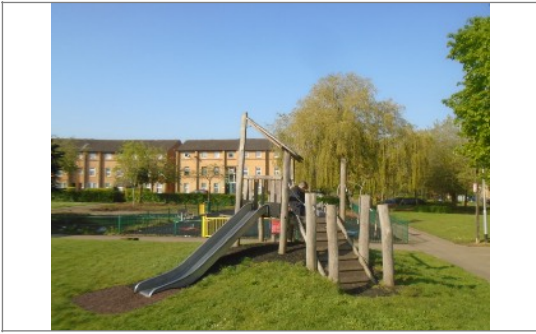
<b>Item</b>	Tower Multiplay Unit				
<b>Supplier</b>	Kompan				
<b>Surface</b>	Rubber Bonded Fibre				
<b>Risk Rating Overall</b>	Very Low	Low	Medium	High	Unacceptable
				13

Cracks/splits evident to most posts. <b>Recommendation:</b> Monitor this condition and refer back to manufacturer for comment if necessary.	9

As above finding. <b>Recommendation:</b> As above comment.	9

Exposed screw fixings evident in places. <b>Recommendation:</b> Remove this condition and refer back to manufacturer for comment if necessary.	8

Weathered wooden items. <b>Recommendation:</b> Consider to re-stain areas.	6

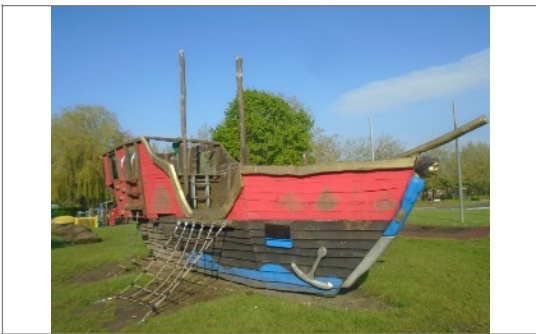
<b>Item</b>	Ship Multiplay Unit (Limited life item)				
<b>Supplier</b>	Ziegler Spielplatze				
<b>Surface</b>	Grass Matting				
<b>Risk Rating Overall</b>	Very Low	Low	Medium	High	Unacceptable
			12

Some areas of timber appear to show evidence of splits/decay in places. <b>Recommendation:</b> Repair/replace areas as required asap.	12

As above finding. <b>Recommendation:</b> As above comment.	12

As above. <b>Recommendation:</b> As above.	12

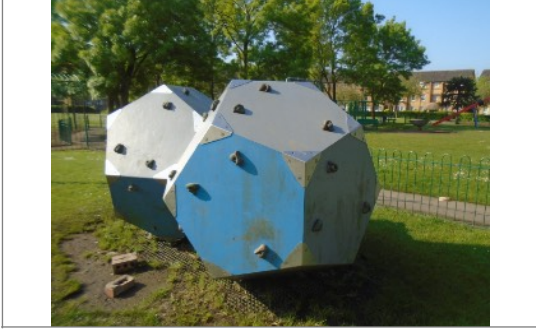
Worn surface and bricks evident on site. <b>Recommendation:</b> Repair surface and remove bricks.	8
---	---	---

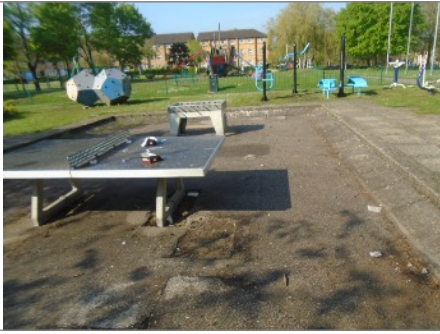
<b>Item</b>	Games Area				
<b>Supplier</b>	Unknown				
<b>Surface</b>	Tarmac				
<b>Risk Rating Overall</b>	Very Low	Low	Medium	High	Unacceptable
				13

Uneven trip hazard on tarmac. <b>Recommendation:</b> Repair as required <b>asap.</b>	13
 	As above finding. <b>Recommendation:</b> As above comment.	13

Damaged surrounding surface and steps. <b>Recommendation:</b> Repair as necessary <b>asap.</b>	13
	<b>Recommendation:</b>

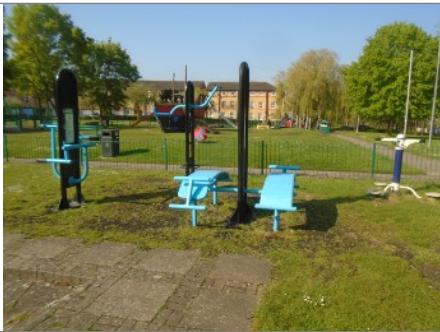
<b>Item</b>	Various Gym Items x 5				
<b>Supplier</b>	Great Outdoor Gym Co. & Others				
<b>Surface</b>	Grass Matting & Rubber Bonded Fibre				
<b>Risk Rating Overall</b>	Very Low	Low	Medium	High	Unacceptable
		7

Rust/corrosion evident in some areas. <b>Recommendation:</b> Monitor to rub down and repaint as required.	6

Gaps in matting. <b>Recommendation:</b> Repair as required.	6

Rubber bonded fibre breaking up. <b>Recommendation:</b> Repair/replace as necessary.	7

Signage missing on some items. <b>Recommendation:</b> Replace as required.	7

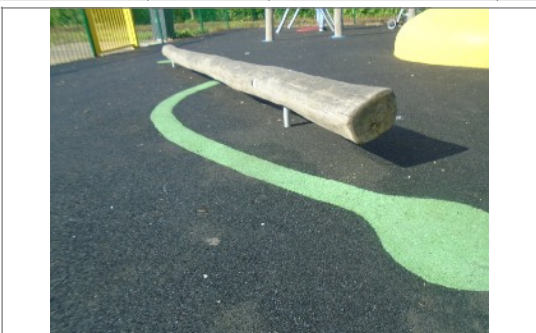
<b>Item</b>	Balance Log				
<b>Supplier</b>	Europlay				
<b>Surface</b>	Wet Pour				
<b>Risk Rating Overall</b>	Very Low	Low	Medium	High	Unacceptable
		6

Splits/cracks and decay evident in wooden posts.  
**Recommendation:**  
 Monitor this condition & keep free from sharp edges.

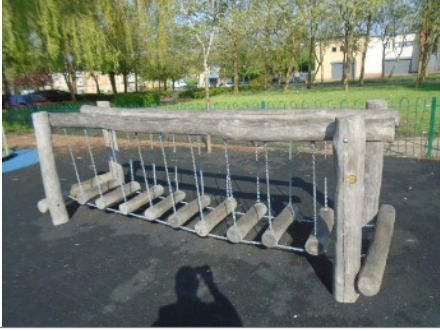
<b>Item</b>	Wobble Bridge				
<b>Supplier</b>	Europlay				
<b>Surface</b>	Wet Pour				
<b>Risk Rating Overall</b>	Very Low	Low	Medium	High	Unacceptable
		7

Splits/cracks and decay evident in wooden posts. <b>Recommendation:</b> Monitor this condition & keep free from sharp edges.	7

As above finding. <b>Recommendation:</b> As above comment.	7
	<b>Recommendation:</b>	
	<b>Recommendation:</b>

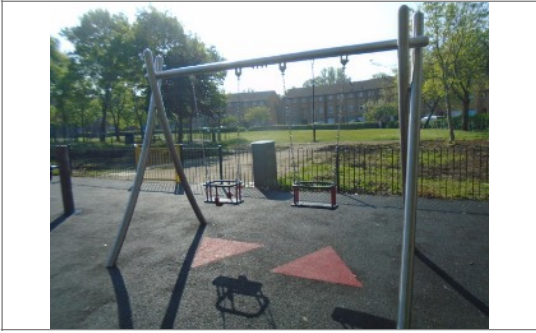
<b>Item</b>	1 Bay 2 Cradle Swing				
<b>Supplier</b>	Still GmbH				
<b>Surface</b>	Wet Pour				
<b>Risk Rating Overall</b>	Very Low	Low	Medium	High	Unacceptable
				13

Possible movement clash evident with roundabout. <b>Recommendation:</b> Monitor this condition.	7

Broken/missing crutch strap. <b>Recommendation:</b> Replace as required <b>asap.</b>	13

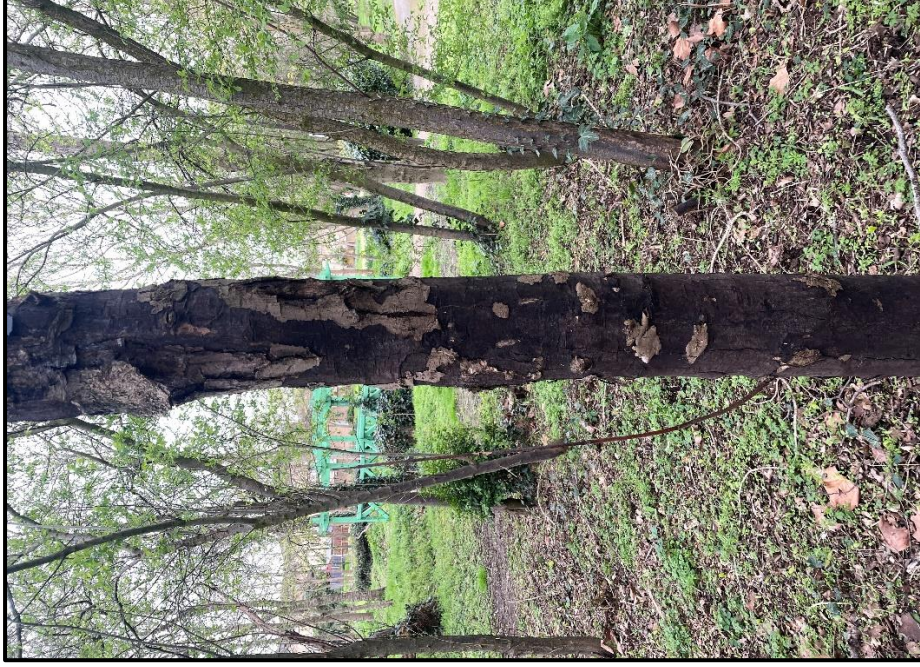
**Figure 2:** a view of the sooty bark disease on 3913 (sycamore) Oldbrook Green.

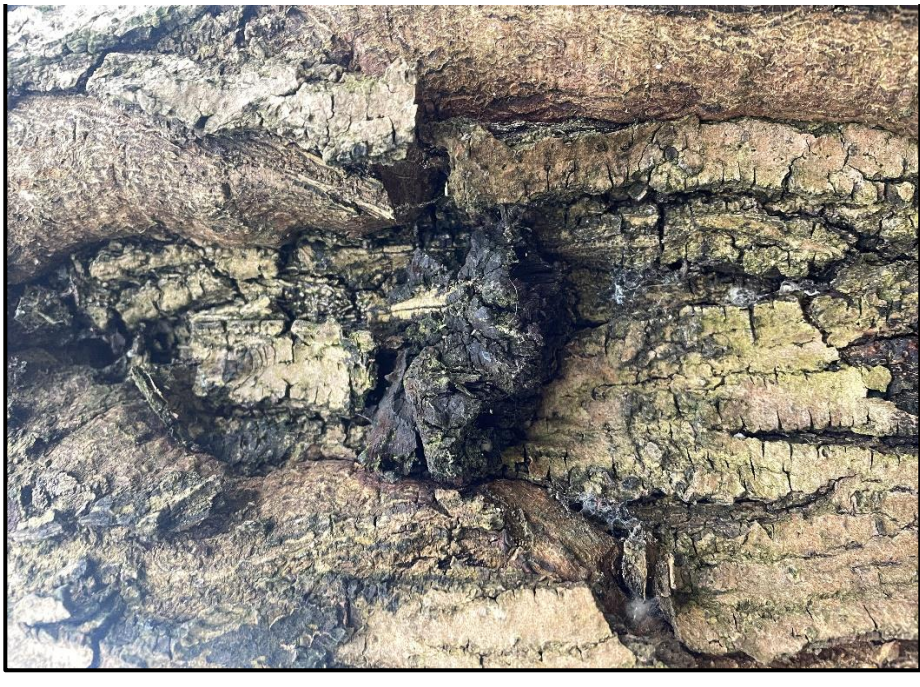
Oldbrook Green	3914	Ash	<i>Fraxinus excelsior</i>	Single	Medium	Young Mature	Fungal fruiting body of <i>Inonotus hispidus</i> on main stem at 1.6m and 3m (southeast). Within striking distance of main road. Increased likelihood of stem failure.	Remove the tree.	To be done asap
Oldbrook Green	3915	Sycamore	<i>Acer pseudoplatanus</i>	Single	Medium	Young Mature	Sooty bark disease. Crown dieback.	Remove to ground level to reduce risk of failure and the fungus spreading to other sycamore trees. Contactor to wear appropriate PPE (e.g. FFP3 mask).	To be done asap
Oldbrook Green	3916	Sycamore	<i>Acer pseudoplatanus</i>	Single	Medium	Young Mature	Sooty bark disease. Crown dieback.	Remove to ground level to reduce risk of failure and the fungus spreading to other sycamore trees. Contactor to wear appropriate PPE (e.g. FFP3 mask).	To be done asap

**Figure 3:** remnants of a fungal bracket (*Inonotus hispidus*) on 3914 (ash) Oldbrook Green
