**Meeting of the**  
**ESTATES COMMITTEE**  
**Will be held at the Springfield Centre,**  
**Springfield Boulevard, Springfield**  
**on**  
**Tuesday 11 June 2024 at 6.30pm**

# Annual Inspection Report

**Kernow Crescent Play Area**

<b>Client:</b>	Campbell Park Community Council
<b>Address:</b>	1 Pencarrow Place Fishermead Milton Keynes MK6 2AS
<b>Date:</b>	7th May 2024
<b>Inspector:</b>	Peter Briggs

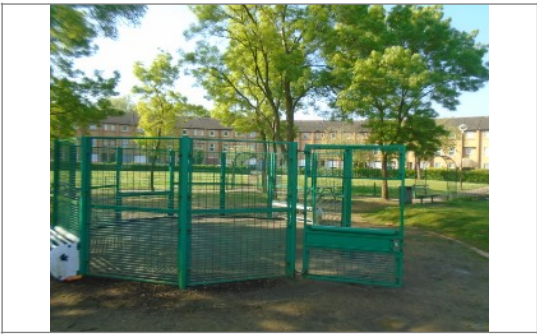
**Findings at the time of inspection with risk number**

No faults found during the inspection. <b>Recommendation:</b> No action required, monitor this area.	5
	<b>Recommendation:</b>	
	<b>Recommendation:</b>	
	<b>Recommendation:</b>

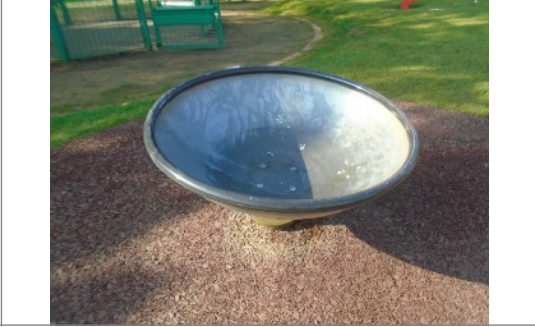
<b>Item</b>	Spinning Dish				
<b>Supplier</b>	Sutcliffe				
<b>Surface</b>	Rubber Bonded Fibre				
<b>Risk Rating Overall</b>	Very Low	Low	Medium	High	Unacceptable
		7

No faults found during the inspection. <b>Recommendation:</b> No action required, monitor this item.	7
	<b>Recommendation:</b>	
	<b>Recommendation:</b>	
	<b>Recommendation:</b>

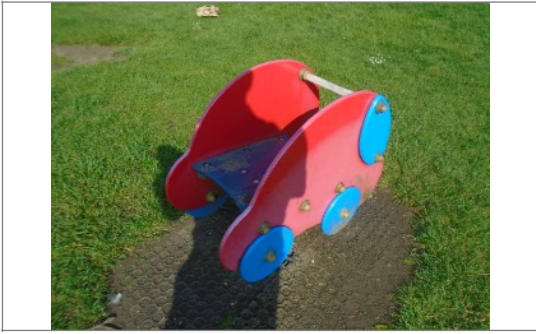
<b>Item</b>	Van Rocker				
<b>Supplier</b>	Unknown				
<b>Surface</b>	Grass Matting				
<b>Risk Rating Overall</b>	Very Low	Low	Medium	High	Unacceptable
		4

No faults found during the inspection.  
**Recommendation:**  
 No action required, monitor this item.

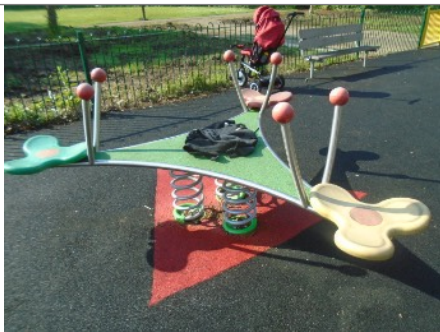
<b>Item</b>	Triple Seat Spring Seesaw				
<b>Supplier</b>	Unknown				
<b>Surface</b>	Wet Pour				
<b>Risk Rating Overall</b>	Very Low	Low	Medium	High	Unacceptable
		5

No faults found during the inspection. <b>Recommendation:</b> No action required, monitor this item.	5
	<b>Recommendation:</b>	
	<b>Recommendation:</b>	
	<b>Recommendation:</b>

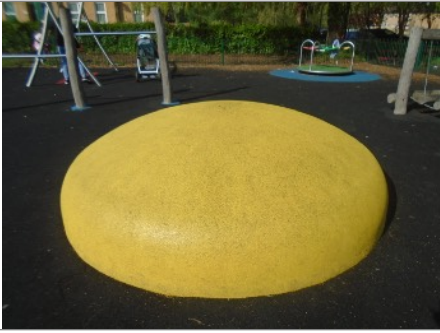
<b>Item</b>	Wet Pour Mound				
<b>Supplier</b>	Unknown				
<b>Surface</b>	Wet Pour				
<b>Risk Rating Overall</b>	Very Low	Low	Medium	High	Unacceptable
		4

As above finding. <b>Recommendation:</b> As above comment.	7
	<b>Recommendation:</b>	
	<b>Recommendation:</b>

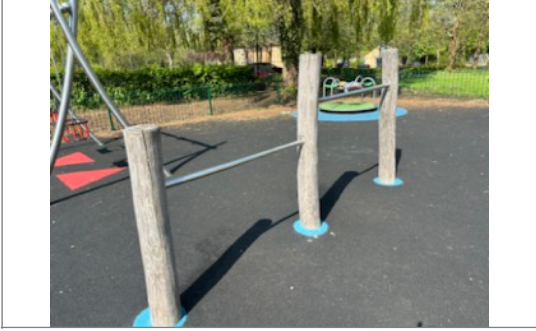
<b>Item</b>	Chin Up Bars				
<b>Supplier</b>	Unknown				
<b>Surface</b>	Wet Pour				
<b>Risk Rating Overall</b>	Very Low	Low	Medium	High	Unacceptable
		6

Splits/cracks evident to posts. <b>Recommendation:</b> Monitor to remove any sharp edges.	6
	<b>Recommendation:</b>	
	<b>Recommendation:</b>	
	<b>Recommendation:</b>

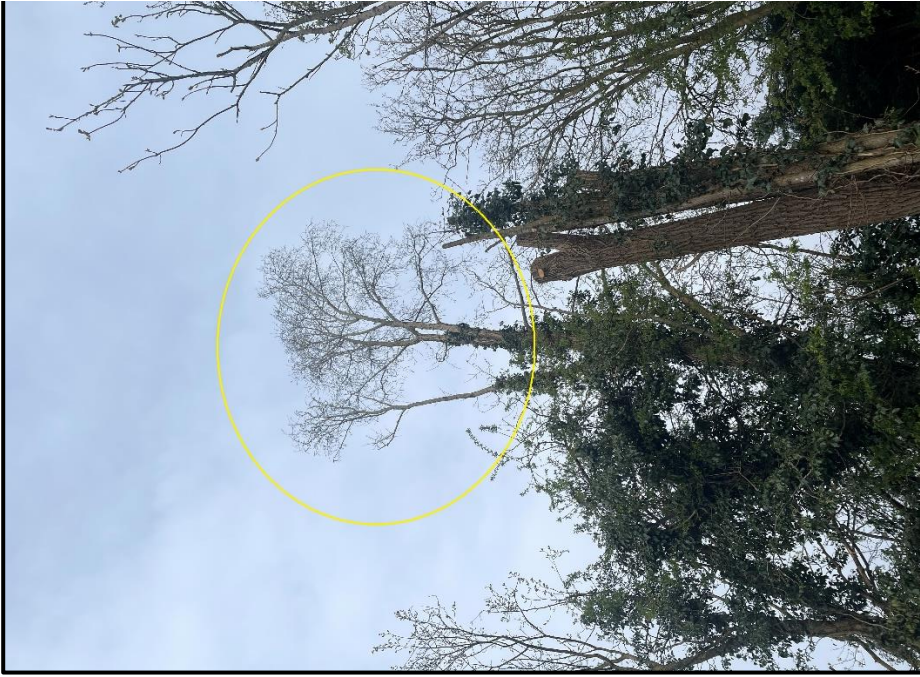
**Figure 1:** a view of 3893 (willow) situated at Woolstone Pond.
